E6298.01-113-11-R0
ACOUSTICAL PERFORMANCE TEST REPORT
ASTM E90

THERMA-TRU CORPORATION

**Series/Model: 3/0 x 8/0 Fiber-Classic/Smooth-Star,
Full Lite Flush Glazed**

Type: Side-Hinged Single Door System

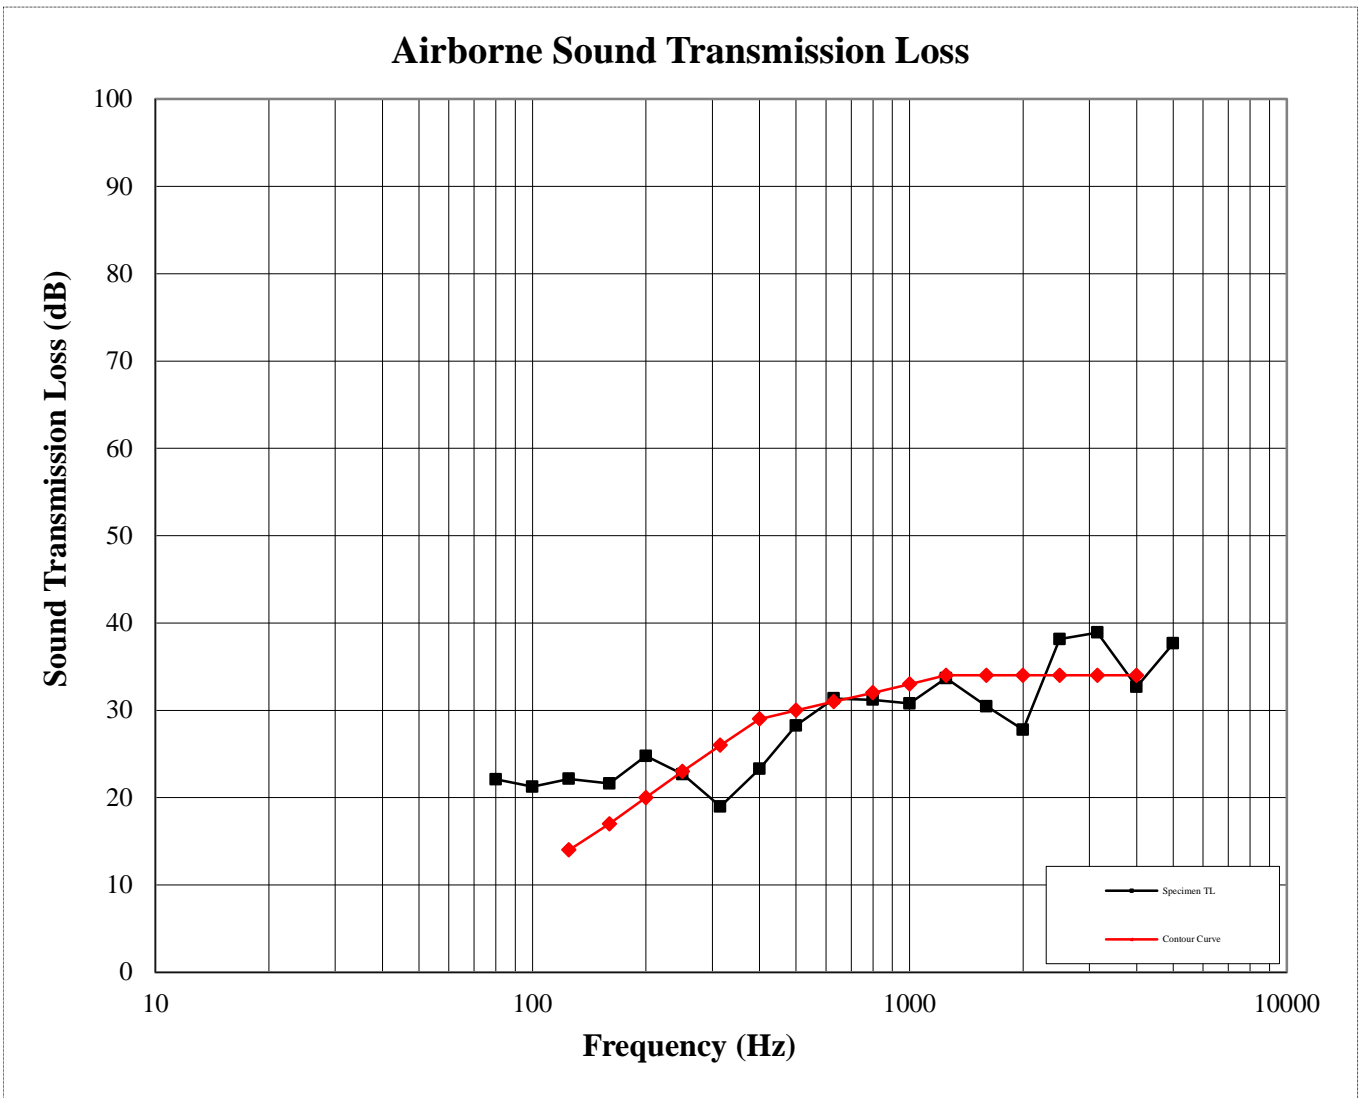
Test Date	04/23/15					
Data File No.	E6298.01A1					
Client	Therma-Tru Corporation					
Description	Series/Model: 3/0 x 8/0 Fiber-Classic/Smooth-Star, full lite flush glazed, side-hinged single door system with 5/8" IG (1/8" tempered, 3/8" air space, 1/8" tempered), sealed with duct tape on both sides, (inoperable)					
Specimen Area	2.37 m ²	Receive Temp.	21.1 °C		Source Temp.	20.9 °C
Technician	Daniel P. Platts	Receive Humidity	44%		Source Humidity	44%

STC Rating **30** *(Sound Transmission Class)*
Deficiencies 29 *(Sum of Deficiencies)*
OITC Rating **26** *(Outdoor-Indoor Transmission Class)*
EWNR Rating **31** *(Exterior Wall Noise Reduction)*

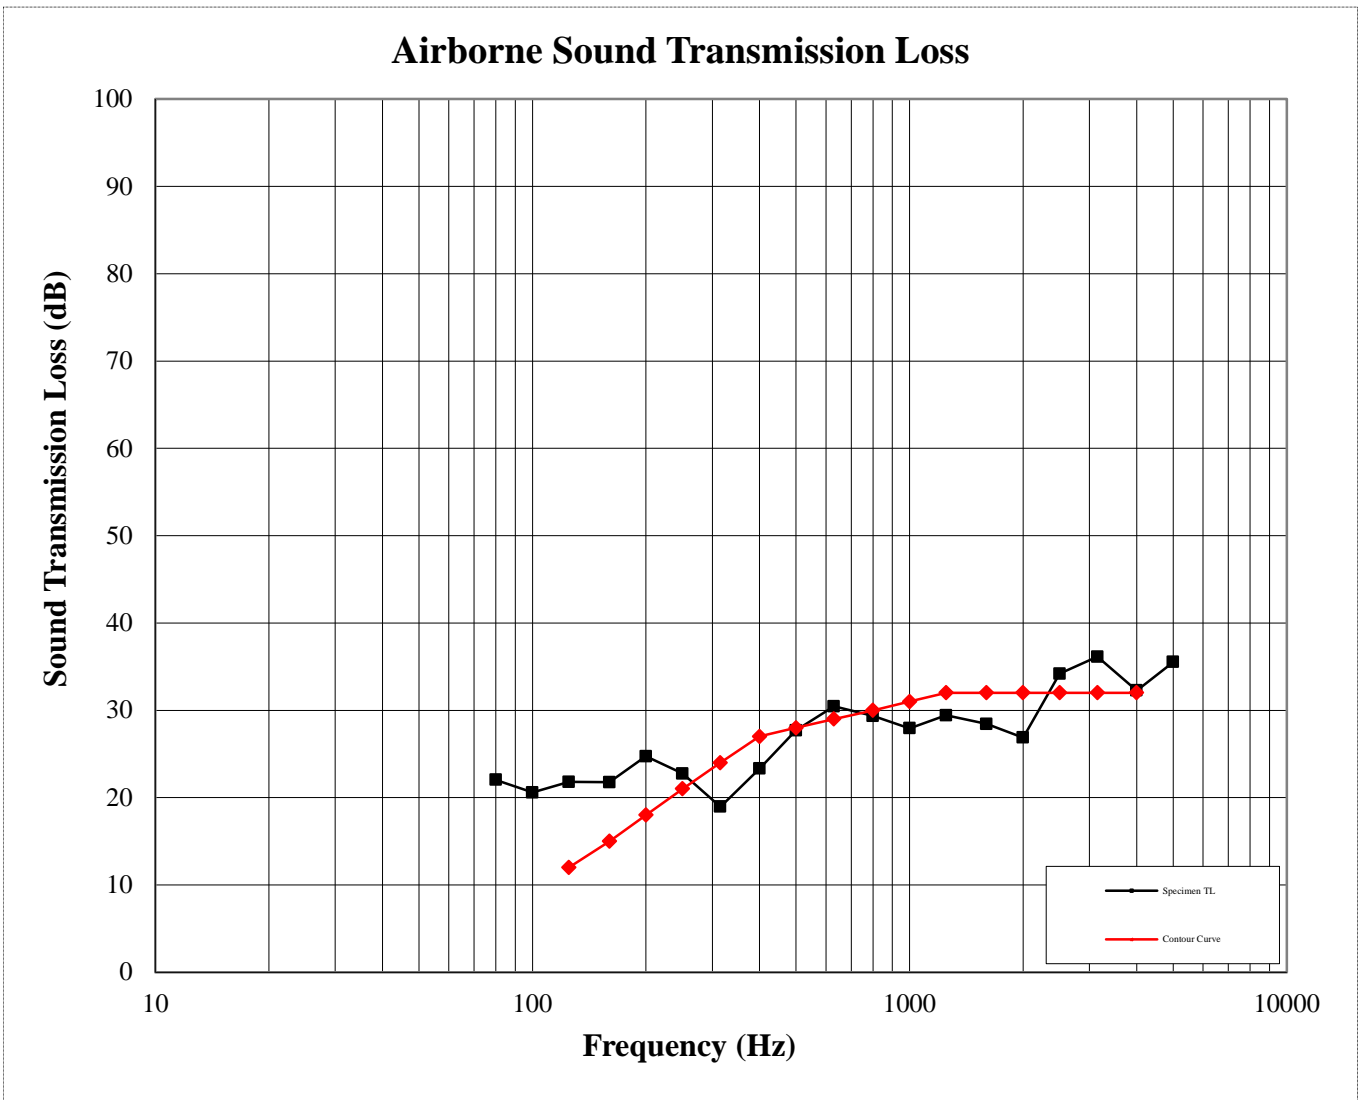
Test Date	04/23/15					
Data File No.	E6298.01A					
Client	Therma-Tru Corporation					
Description	Series/Model: 3/0 x 8/0 Fiber-Classic/Smooth-Star, full lite flush glazed, side-hinged single door system with 5/8" IG (1/8" tempered, 3/8" air space, 1/8" tempered), (operable)					
Specimen Area	2.37 m ²	Receive Temp.	21.1 °C		Source Temp.	20.9 °C
Technician	Daniel P. Platts	Receive Humidity	44%		Source Humidity	44%

STC Rating **28** *(Sound Transmission Class)*
Deficiencies **25** *(Sum of Deficiencies)*
OITC Rating **25** *(Outdoor-Indoor Transmission Class)*
EWNR Rating **30** *(Exterior Wall Noise Reduction)*

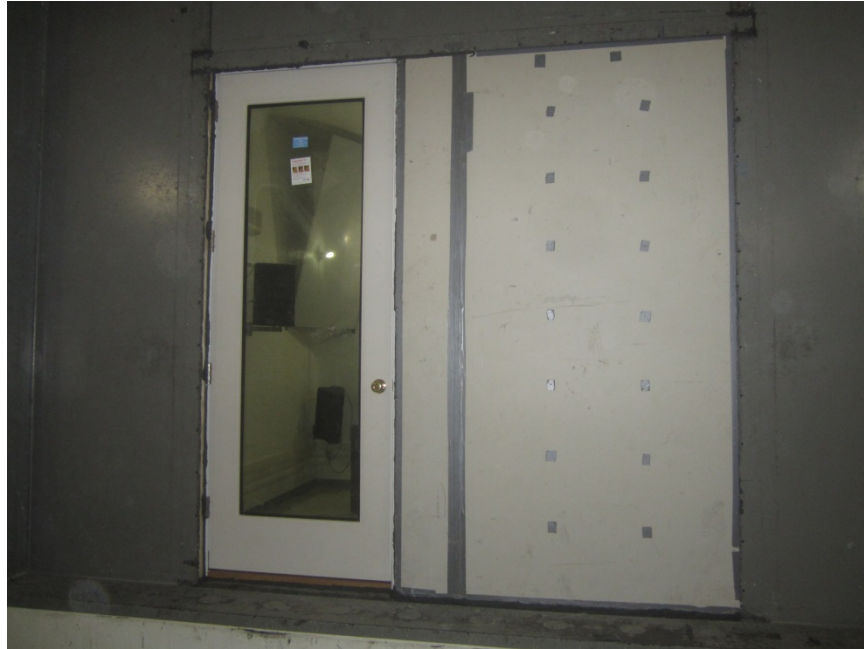
Receive Room View of Installed Specimen

The specimen plug was removed from the filler wall assembly. The specimen was placed on a foam isolation pad in the test opening. Duct seal was used to seal the perimeter of the specimen to the test opening on both sides. The interior side of the specimen frame, when installed, was approximately 1/4" from being flush with the receive room side of the filler wall. A stethoscope was used to check for any abnormal air leaks around the test specimen prior to testing. Operable portions of the test specimen, if any, were cycled at least five times prior to testing.

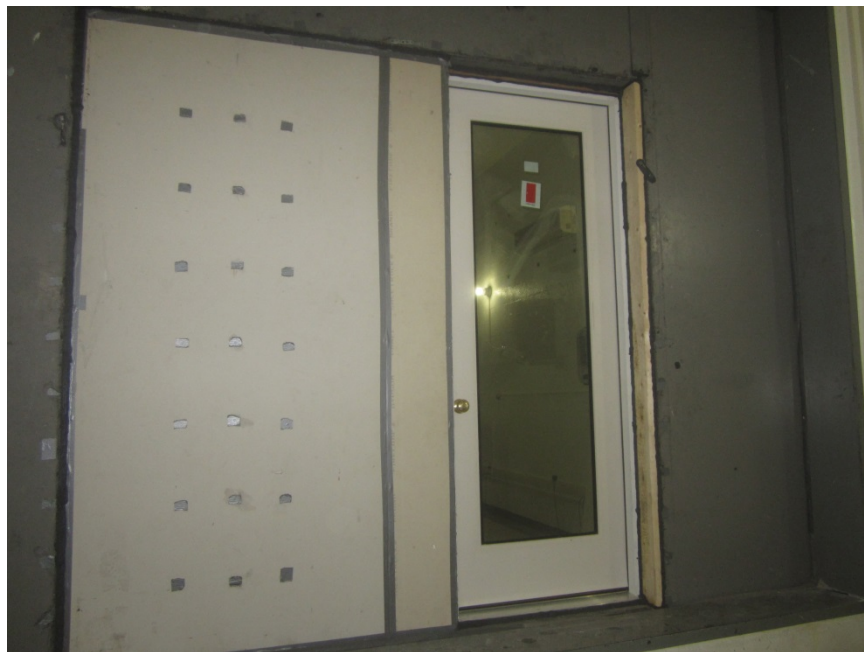
Source Room View of Installed Specimen
