**E6298.02-113-11-R0**  
**ACOUSTICAL PERFORMANCE TEST REPORT**  
**ASTM E90**

**THERMA-TRU CORPORATION**

**Series/Model: 3/0 x 8/0 Fiber-Classic/Smooth-Star,  
Full Lite 1" IG Impact Glass with BTS Lite Frame**

**Type: Side-Hinged Single Door System**

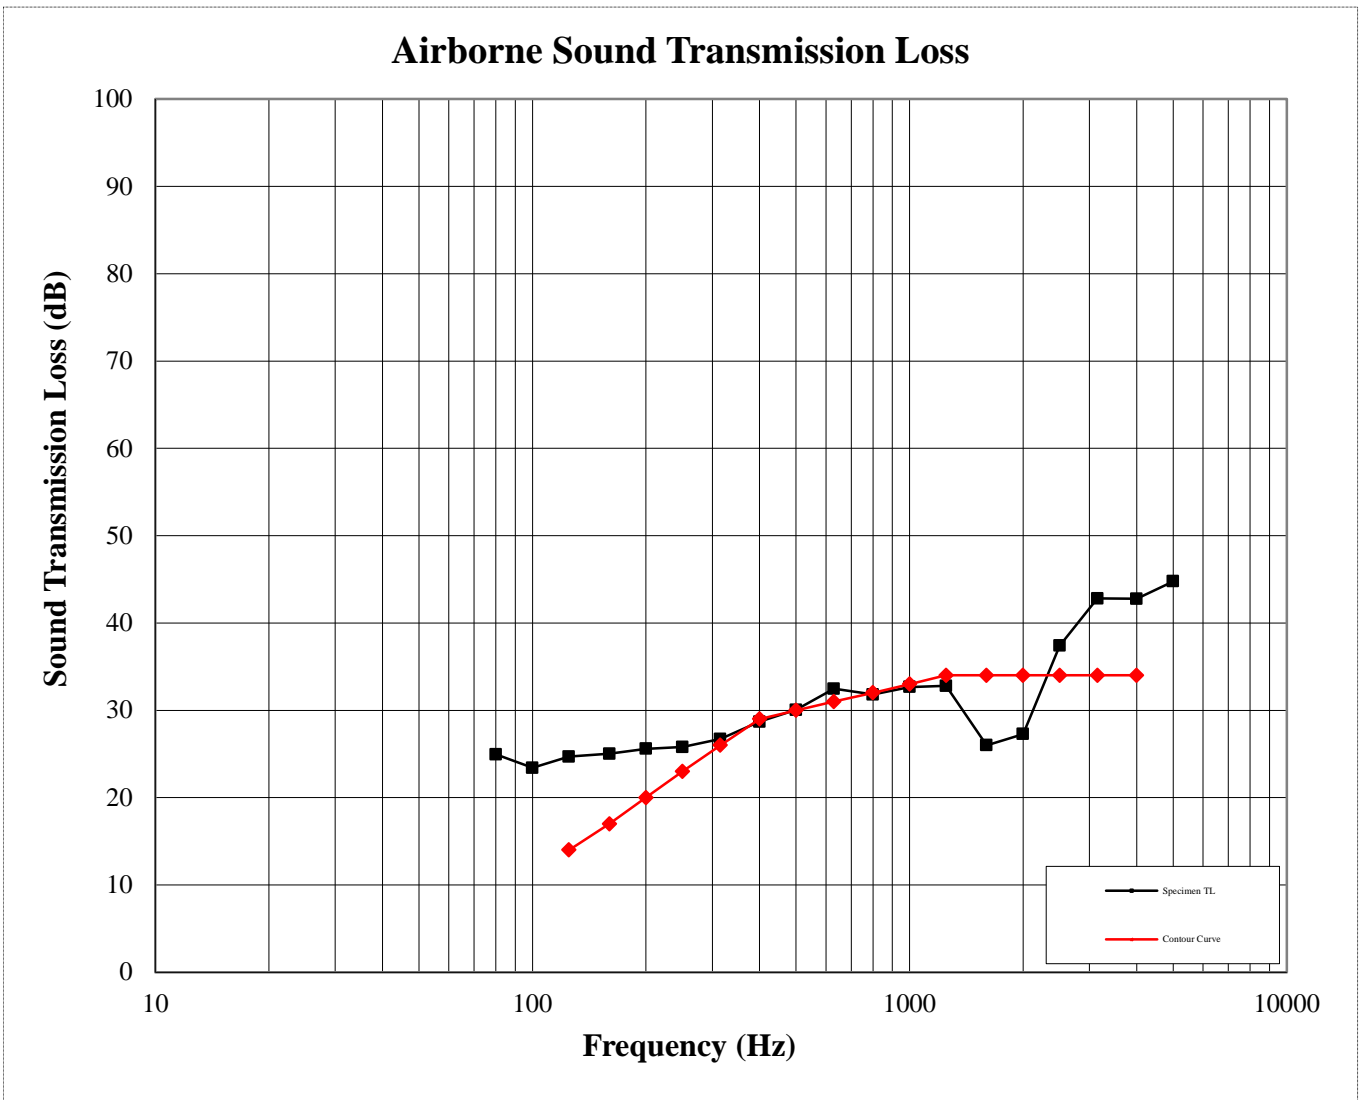
**AIRBORNE SOUND TRANSMISSION LOSS**  
ASTM E 90

**STC Rating**      **30**      *(Sound Transmission Class)*  
**Deficiencies**      16      *(Sum of Deficiencies)*  
**OITC Rating**      **29**      *(Outdoor-Indoor Transmission Class)*  
**EWNR Rating**      **33**      *(Exterior Wall Noise Reduction)*

<b>Test Date</b>	04/24/15					
<b>Data File No.</b>	E6298.01B1					
<b>Client</b>	Therma-Tru Corporation					
<b>Description</b>	Series/Model: 3/0 x 8/0 Fiber-Classic/Smooth-Star, full lite 1" IG impact glass with BTS lite frame, side-hinged single door system with 1" IG (1/8" tempered exterior, 1/2" air space, 3/8" laminated interior), Glass temperature 75°F, sealed with duct tape on both sides, (inoperable)					
<b>Specimen Area</b>	2.37 m <sup>2</sup>	Receive Temp.	22.7 °C		Source Temp.	22.8 °C
<b>Technician</b>	Daniel P. Platts	Receive Humidity	46%		Source Humidity	45%

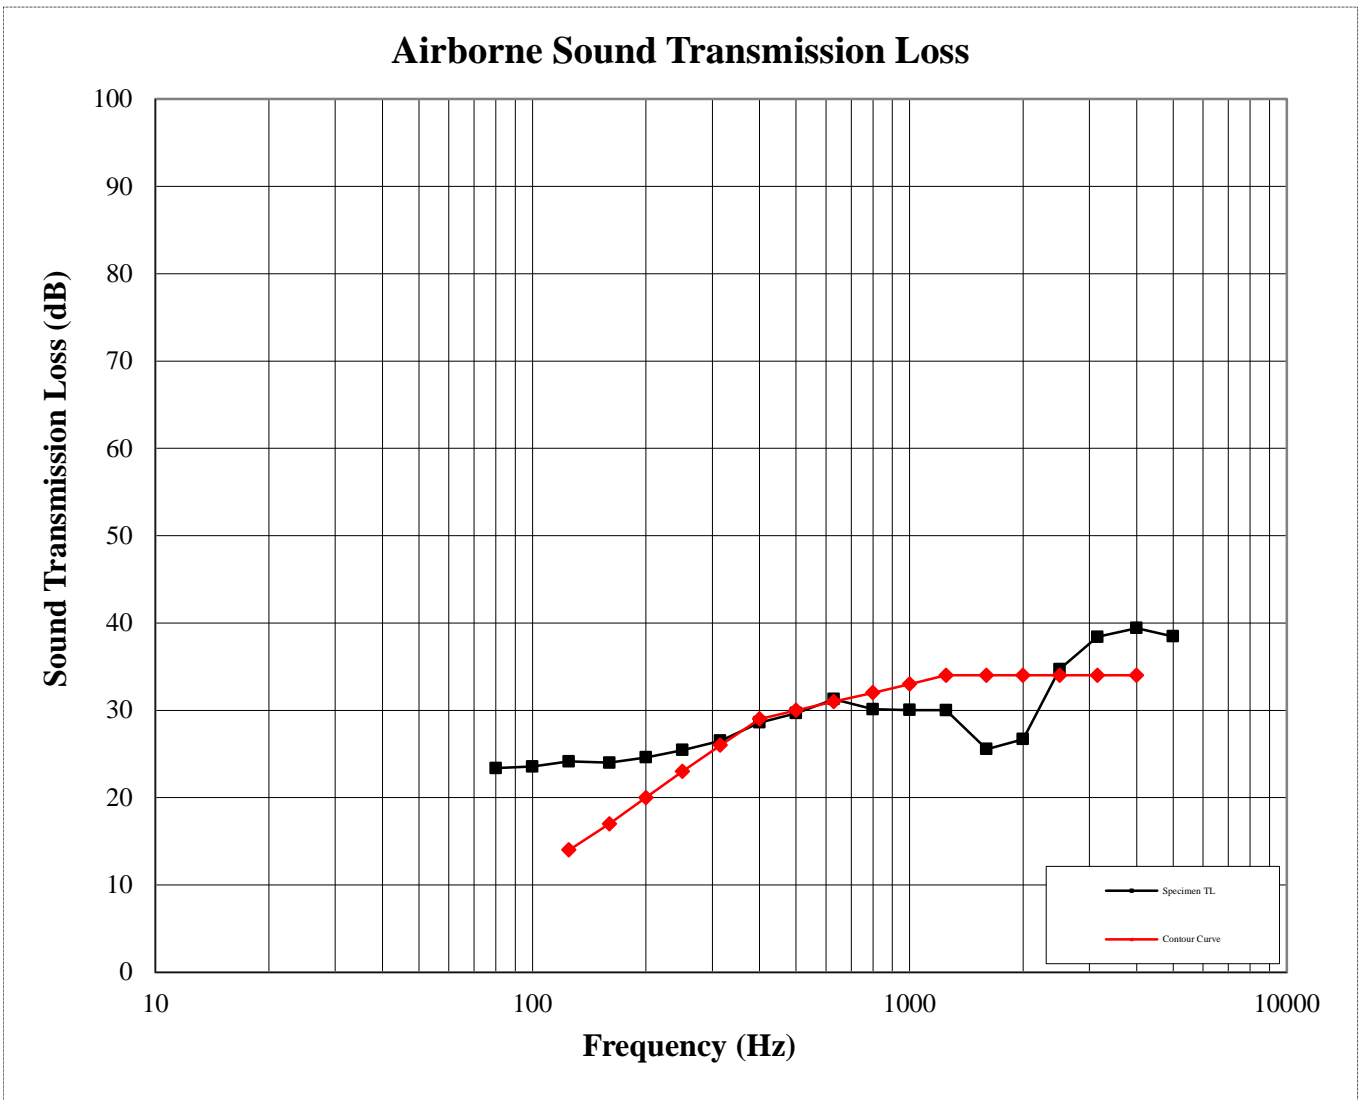
### AIRBORNE SOUND TRANSMISSION LOSS ASTM E 90

**STC Rating**      **30**      *(Sound Transmission Class)*  
**Deficiencies**      24      *(Sum of Deficiencies)*  
**OITC Rating**      **28**      *(Outdoor-Indoor Transmission Class)*  
**EWNR Rating**      **32**      *(Exterior Wall Noise Reduction)*

<b>Test Date</b>	04/23/15					
<b>Data File No.</b>	E6298.01B					
<b>Client</b>	Therma-Tru Corporation					
<b>Description</b>	Series/Model: 3/0 x 8/0 Fiber-Classic/Smooth-Star, full lite 1" IG impact glass with BTS lite frame, side-hinged single door system with 1" IG (1/8" tempered exterior, 1/2" air space, 3/8" laminated interior), Glass temperature 75°F (operable)					
<b>Specimen Area</b>	2.37 m <sup>2</sup>	Receive Temp.	20.8 °C		Source Temp.	21.0 °C
<b>Technician</b>	Daniel P. Platts	Receive Humidity	45%		Source Humidity	45%

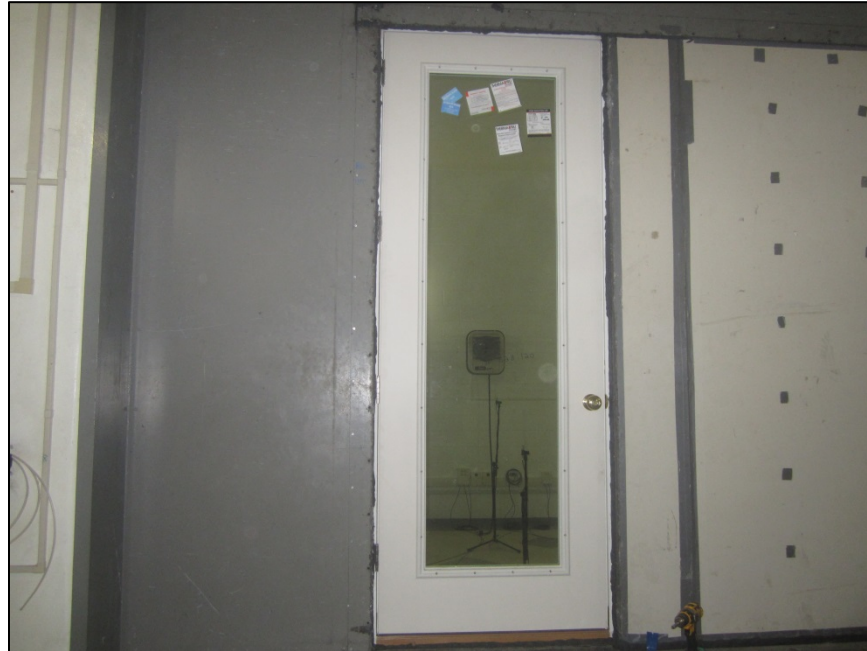
**Receive Room View of Installed Specimen**

The specimen plug was removed from the filler wall assembly. The specimen was placed on a foam isolation pad in the test opening. Duct seal was used to seal the perimeter of the specimen to the test opening on both sides. The interior side of the specimen frame, when installed, was approximately 1/4" from being flush with the receive room side of the filler wall. A stethoscope was used to check for any abnormal air leaks around the test specimen prior to testing. Operable portions of the test specimen, if any, were cycled at least five times prior to testing.

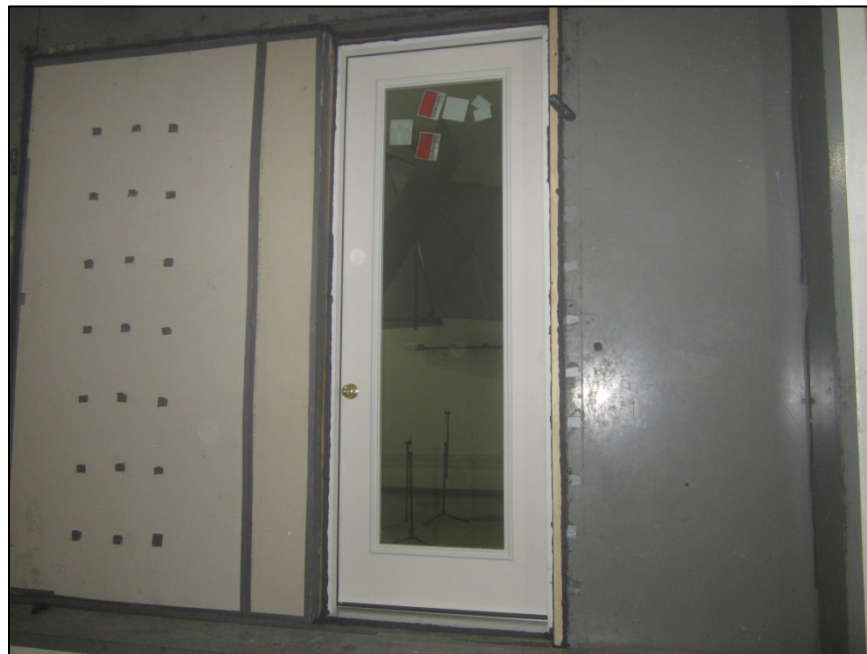
**Source Room View of Installed Specimen**
