# **THERMA-TRU CORPORATION**

# **ACOUSTICAL PERFORMANCE TEST REPORT**

ASTM E90 SOUND TRANSMISSION LOSS TESTING ON A  
FIBERGLASS NOISE REDUCTION DOOR, 3068 HIGH PERFORMANCE DOOR WITH  
FIBERGLASS SKIN

H6980.01-113-11-R0

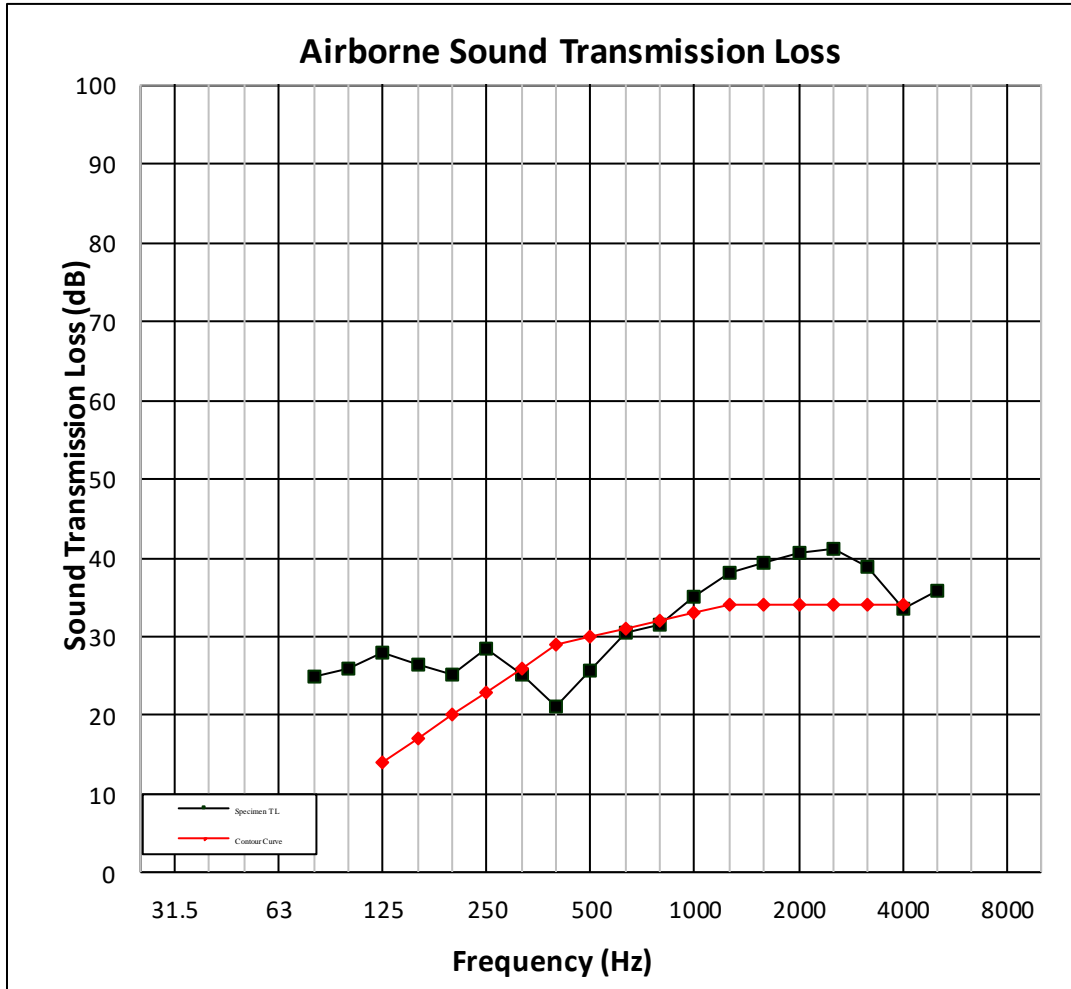
### H6981.01A GRAPH (INOPERABLE CONDITION)

#### H6981.01A (INOPERABLE CONDITION)

<b>SPECIMEN AREA</b>	1.99 m <sup>2</sup>	<b>RECEIVE TEMP.</b>	22.1 °C	<b>SOURCE TEMP</b>	20.5 °C
<b>TECHNICIAN</b>	Zachary Gol	<b>RECEIVE HUMIDITY</b>	49%	<b>SOURCE HUMIDITY</b>	48%

FREQ (Hz)	BACKGROUND SPL (dB)	ABSORPTION (m <sup>2</sup> )	SOURCE SPL (dB)	RECEIVE SPL (dB)	SPECIMEN TL (dB)	95% CONFIDENCE LIMIT	NUMBER OF DEFICIENCIES
80	36.2	5.2	105	78	25	1.44	-
100	35.3	6.2	106	76	26	1.64	-
125	33.0	5.2	105	74	28	1.43	0
160	38.7	4.4	105	76	26	0.96	0
200	35.2	4.6	107	78	25	0.79	0
250	31.3	5.3	107	75	28	0.58	0
315	27.3	5.6	99	70	25	0.38	1
400	24.6	6.0	96	70	21	0.60	8
500	22.2	6.0	97	66	26	0.48	4
630	19.4	5.7	101	66	31	0.53	0
800	18.2	6.0	100	64	32	0.45	0
1000	13.1	6.1	97	57	35	0.46	0
1250	14.2	6.6	98	54	38	0.26	0
1600	11.2	7.1	101	56	39	0.33	0
2000	7.3	7.5	95	49	41	0.32	0
2500	6.2	8.5	94	46	41	0.27	0
3150	5.1	10.2	97	51	39	0.24	0
4000	5.5	12.6	95	54	34	0.26	0
5000	6.3	16.1	94	49	36	0.31	-
<b>STC RATING</b>	30 (Sound Transmission Class)						
<b>DEFICIENCIES</b>	13 (Sum of Deficiencies)						
<b>OITC RATING</b>	28 (Outdoor-Indoor Transmission Class)

<b>SERIES/MODEL</b>	Fiberglass Noise Reduction Door
<b>TYPE</b>	3068 High Performance Door with Fiberglass Skin
<b>DESCRIPTION</b>	1/2" IG (1/8" tempered, 1/4" air space, 1/8" tempered)
<b>TEST CONDITION</b>	Inoperable (sealed with duct seal on both sides)
<b>DATA FILE NO.</b>	H6980.01A
<b>STC</b>	30
<b>OITC</b>	28

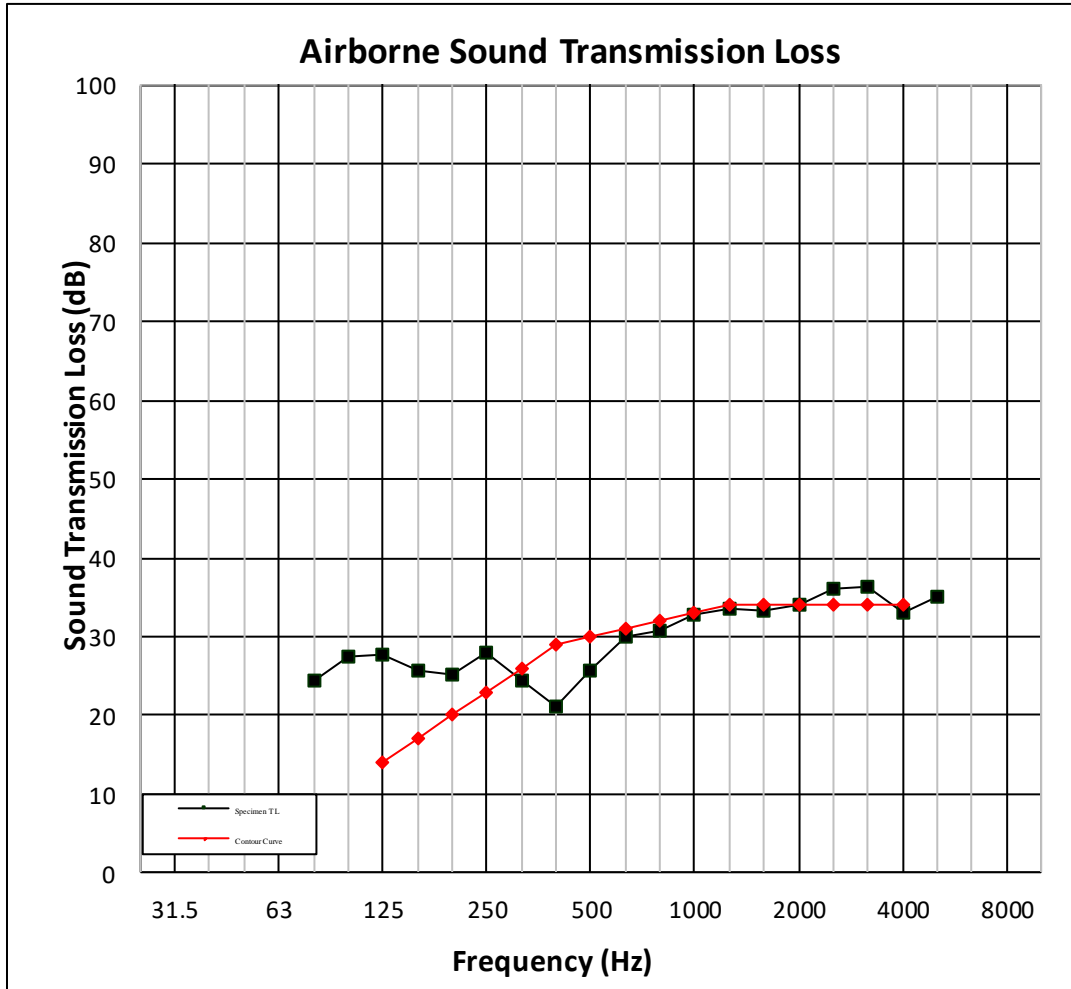
### H6981.01A1 GRAPH (OPERABLE CONDITION)

### H6981.01A1 (OPERABLE CONDITION)

<b>SPECIMEN AREA</b>	1.99 m <sup>2</sup>	<b>RECEIVE TEMP.</b>	22.1 °C	<b>SOURCE TEMP</b>	21.1 °C
<b>TECHNICIAN</b>	Zachary Gol	<b>RECEIVE HUMIDITY</b>	48%	<b>SOURCE HUMIDIT</b>	47%

FREQ (Hz)	BACKGROUND SPL (dB)	ABSORPTION (m <sup>2</sup> )	SOURCE SPL (dB)	RECEIVE SPL (dB)	SPECIMEN TL (dB)	95% CONFIDENCE LIMIT	NUMBER OF DEFICIENCIES
80	38.4	5.0	105	78	24	1.60	-
100	33.8	5.3	106	76	27	1.91	-
125	34.9	5.6	105	74	28	1.18	0
160	38.7	4.4	105	76	26	1.02	0
200	35.4	4.6	107	78	25	0.80	0
250	29.6	5.2	107	75	28	0.60	0
315	24.3	5.5	99	70	25	0.38	1
400	21.6	5.8	96	70	21	0.54	8
500	18.5	5.9	97	67	26	0.60	4
630	17.7	5.8	101	66	30	0.55	1
800	15.7	6.1	100	65	31	0.49	1
1000	10.8	6.2	97	59	33	0.53	0
1250	9.3	6.7	98	59	34	0.35	0
1600	6.4	7.2	101	62	33	0.37	1
2000	4.7	7.6	95	55	34	0.29	0
2500	4.8	8.6	94	51	36	0.32	0
3150	4.6	10.4	97	53	36	0.25	0
4000	5.2	12.7	95	54	33	0.24	1
5000	6.0	16.3	94	50	35	0.32	-
<b>STC RATING</b>	30 (Sound Transmission Class)						
<b>DEFICIENCIES</b>	17 (Sum of Deficiencies)						
<b>OITC RATING</b>	28 (Outdoor-Indoor Transmission Class)

<b>SERIES/MODEL</b>	Fiberglass Noise Reduction Door
<b>TYPE</b>	3068 High Performance Door with Fiberglass Skin
<b>DESCRIPTION</b>	1/2" IG (1/8" tempered, 1/4" air space, 1/8" tempered)
<b>TEST CONDITION</b>	Operable
<b>DATA FILE NO.</b>	H6980.01A1
<b>STC</b>	30
<b>OITC</b>	28

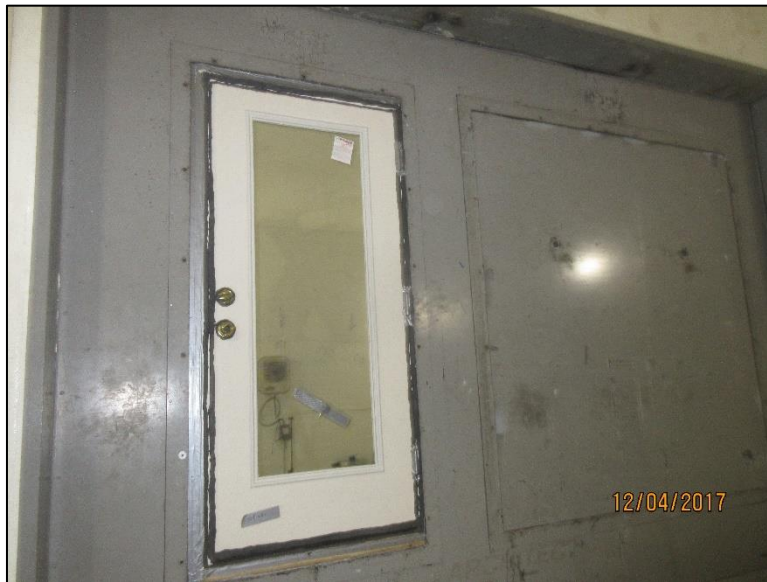
**Photo No. 1**  
**Receive Room View of Test Specimen**

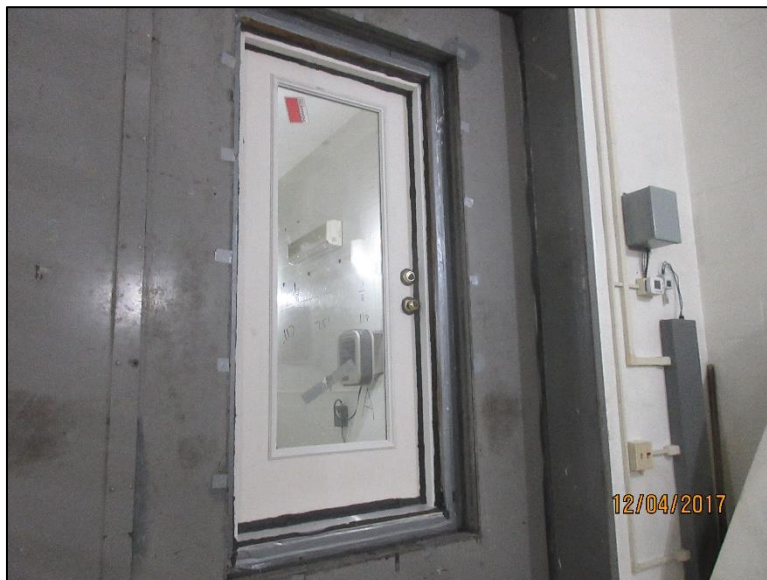
**Photo No. 2**  
**Source Room View of Test Specimen**
