**ASTM E 90 SOUND TRANSMISSION LOSS
TEST REPORT**

THERMA-TRU DOORS

SERIES/MODEL: Classic-Craft, Fiber-Classic, and Smooth-Star

TYPE: 3/6-8 Impact Rated Full Lite Side Hinged Door

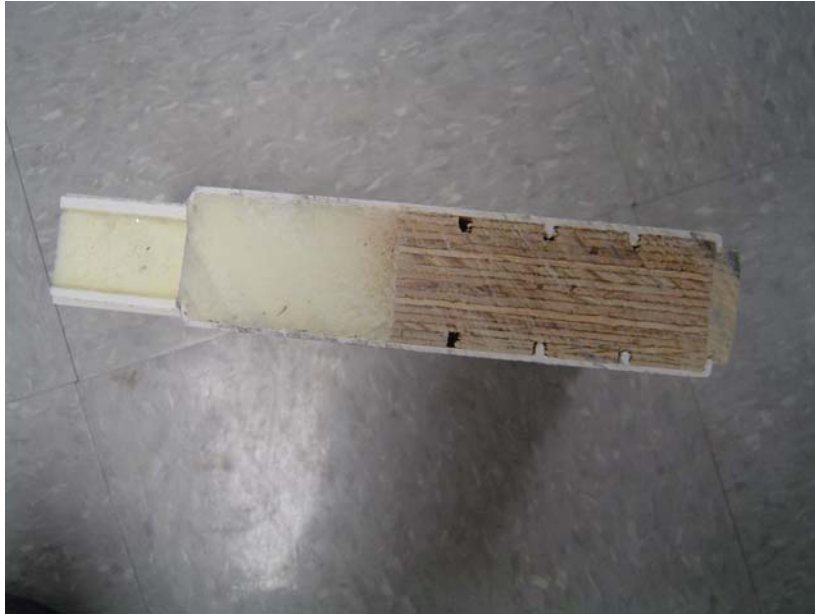
Leaf Cross Section at Lock Stile

Comments: The lock stile was constructed from 3-5/8" by 1-1/2" plywood. The hinge stile was constructed from 7/8" by 1/2" wood. The top rail contained a composite member measuring 1" by 1-1/2". The bottom rail contained a composite member measuring 7/8" by 1-1/2". The door knob and deadbolt holes were reinforced by the lock stile. The hinge stile and lock stile were capped with 5/16" by 1-5/16" wood.

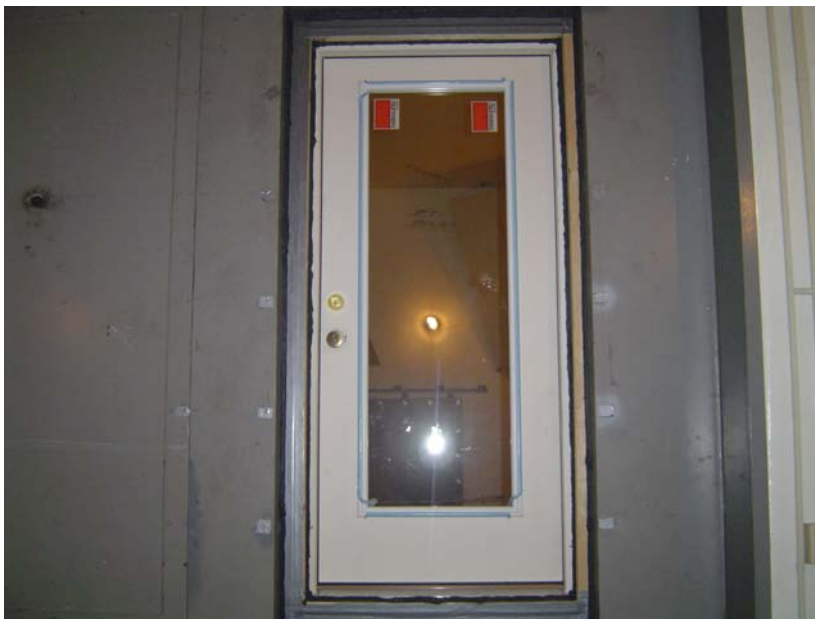
Source Room View of Installed Specimen

The 40" by 86" plug was removed from the filler wall assembly. The door system was placed on a foam isolation pad in the test opening. Duct seal was used to seal the perimeter of the test specimen to the test opening on both sides. The interior side of the door frame, when installed, was approximately 1/4" from being flush with the receiving room side of the filler wall. A stethoscope was used to check for any abnormal air leaks around the test specimen prior to testing. The door panel was opened and closed at least five times prior to testing.
