ASTM E 90 SOUND TRANSMISSION LOSS TEST REPORT

THERMA-TRU DOORS

SERIES/MODEL: Classic-Craft, Fiber Classic, and Smooth Star

Report No: 74385.01-113-11
Test Date: 10/11/07
Report Date: 12/04/07
Expiration Date: 10/11/11

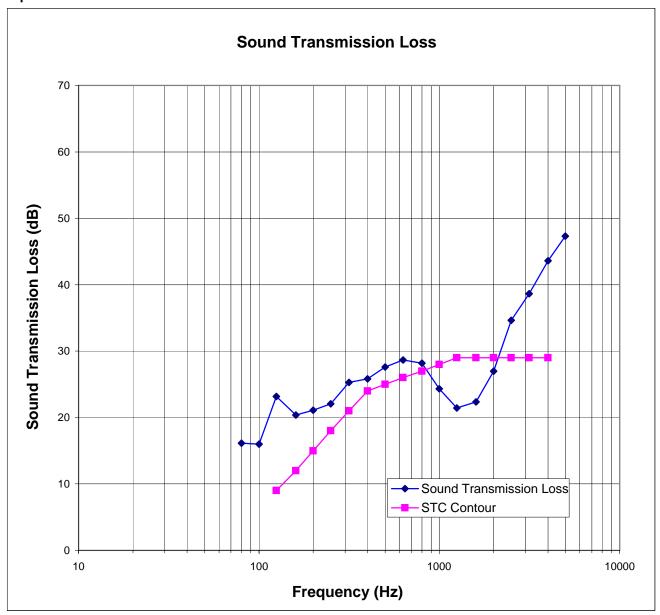
ATI No. 74385.01A **Date** 10/11/07

Specimen Classic-Craft, Fiber-Classic and Smooth Star, side hinged, impact rated door,

Inoperable test

Specimen Area 23.81 Sq Ft Filler Area 116.19 Sq Ft Operator Brandon C. Ward

Bkgrd	Absorp	Source	Receive	Filler	Specimen	95%	No. of	Trans
Freq	SPL	(Sabines	SPL	SPL	TL	TL	Conf	Defici-	Coef
(Hz)	(dB)	/Sq Ft)	(dB)	(dB)	(dB)	(dB)	Limit	encies	Diff
80	39.2	51.8	86.8	67.3	39.0	16	2.75	0	16.0
100	40.4	53.1	88.6	69.2	42.8	16	3.11	0	20.0
125	41.2	48.7	94.5	68.2	53.4	23	3.30	0	23.4
160	42.9	51.3	95.5	71.9	52.7	20	1.49	0	25.5
200	42.8	52.0	100.6	76.1	54.2	21	0.85	0	26.2
250	39.8	54.5	101.0	75.3	55.9	22	0.77	0	26.9
315	36.9	56.0	99.6	70.6	57.3	25	1.06	0	25.1
400	34.5	63.1	99.1	69.1	63.3	26	0.69	0	30.6
500	32.8	60.8	100.7	69.1	66.3	28	0.76	0	31.9
630	27.6	58.3	103.6	71.1	69.0	29	0.30	0	33.5
800	27.7	63.1	103.5	71.1	72.9	28	0.47	0	37.9
1000	27.2	67.3	102.8	74.0	76.7	24	0.40	4	45.5
1250	26.8	72.3	106.0	79.8	78.4	21	0.38	8	50.1
1600	22.6	77.3	112.4	84.9	77.2	22	0.26	7	48.0
2000	16.4	80.3	108.1	75.9	75.7	27	0.29	2	41.9
2500	12.3	91.3	106.8	66.4	77.7	35	0.27	0	36.3
3150	10.4	110.5	107.8	62.5	87.1	39	0.38	0	41.7

STC Rating = 25 (Sound Transmission Class)

Deficiencies =21(Number of deficiencies versus contour curve)OITC Rating =24(Outdoor/Indoor Transmission Class)

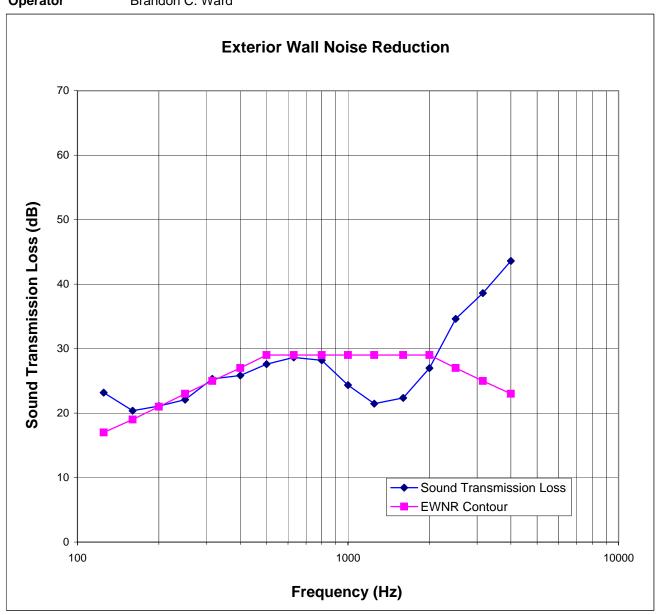
ATI No. 74385.01A **Date** 10/11/07

Specimen Classic-Craft, Fiber-Classic and Smooth Star, side hinged, impact rated door, Inoperable

test

Specimen Area23.81 Sq FtFiller Area116.19 Sq FtOperatorBrandon C. Ward

EWNR Rating= 29 (Exterior Wall Noise Reduction)

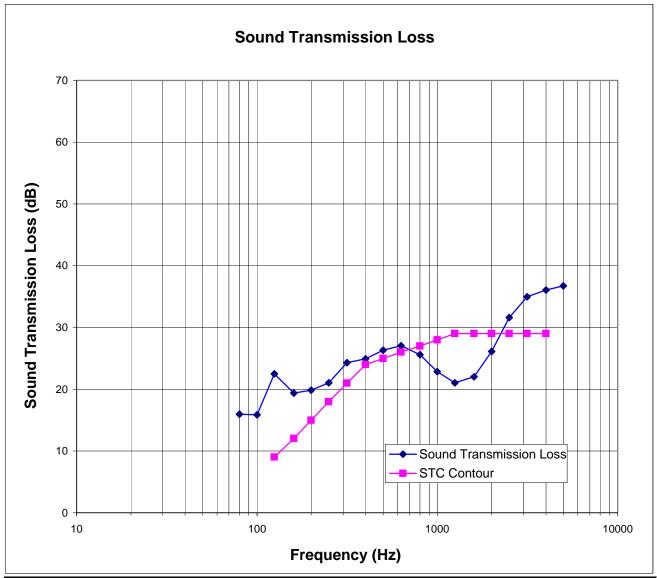
ATI No. 74385.01B **Date** 10/11/07

Specimen Classic-Craft, Fiber-Classic and Smooth Star, side hinged, impact rated door, operable

test

Specimen Area 23.81 Sq Ft Filler Area 116.19 Sq Ft Operator Brandon C. Ward

Bkgrd	Absorp	Source	Receive	Filler	Specimen	95%	No. of	Trans
Freq	SPL	(Sabines	SPL	SPL	TL	TL	Conf	Defici-	Coef
(Hz)	(dB)	/Sq Ft)	(dB)	(dB)	(dB)	(dB)	Limit	encies	Diff
80	43.1	51.5	86.8	67.5	39.0	16	2.18	0	16.2
100	39.3	54.8	88.7	69.3	42.8	16	2.82	0	20.1
125	40.0	52.3	94.7	68.8	53.4	23	3.70	0	24.1
160	43.3	49.1	95.5	73.0	52.7	19	1.34	0	26.5
200	42.9	54.9	100.5	77.1	54.2	20	0.73	0	27.5
250	39.0	53.2	101.1	76.6	55.9	21	0.69	0	28.0
315	36.5	60.4	99.7	71.4	57.3	24	1.16	0	26.1
400	35.8	62.7	99.1	70.0	63.3	25	0.86	0	31.6
500	34.0	63.0	100.9	70.4	66.3	26	0.82	0	33.2
630	28.4	62.1	103.6	72.5	69.0	27	0.26	0	35.1
800	29.3	63.3	103.5	73.7	72.9	26	0.43	1	40.5
1000	28.0	67.6	102.8	75.5	76.7	23	0.36	5	47.0
1250	27.4	72.7	106.0	80.1	78.4	21	0.29	8	50.5
1600	23.5	75.9	112.3	85.3	77.2	22	0.23	7	48.4
2000	15.9	81.4	108.1	76.7	75.7	26	0.23	3	42.7
2500	7.5	91.0	106.8	69.4	77.7	32	0.17	0	39.3
3150	8.2	107.2	107.7	66.2	87.1	35	0.38	0	45.3

STC Rating = 25 (Sound Transmission Class)

Deficiencies = 24 (Number of deficiencies versus contour curve)

OITC Rating = 23 (Outdoor/Indoor Transmission Class)

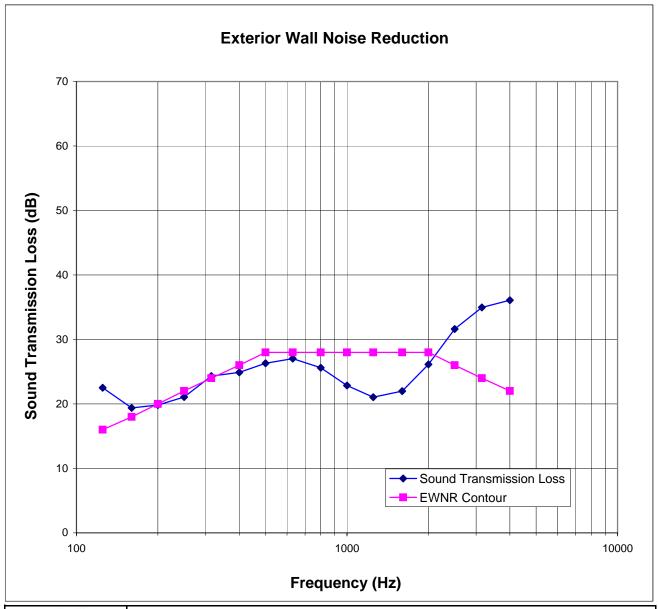
ATI No. 74385.01B **Date** 10/11/07

Specimen Classic-Craft, Fiber-Classic and Smooth Star, side hinged, impact rated door, operable

test

Specimen Area23.81 Sq FtFiller Area116.19 Sq FtOperatorBrandon C. Ward

EWNR Rating= 28 (Exterior Wall Noise Reduction)

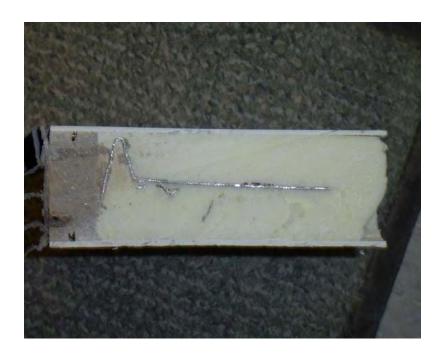
Leaf Cross Section at Bottom Rail

Layers (outside to inside)	Layer Description (material and thickness)
1	0.085" Fiberglass skin
2	1.550" Expanded foam
5	0.085" Fiberglass skin

Comments: The lock stile was constructed from 3-7/8" by 1-1/2" plywood. The hinge stile was constructed from 7/8" by 1-1/2" wood. The top and bottom rail contained a composite member measuring 1" by 1-1/2". The door knob and deadbolt holes were reinforced by the lock stile. The hinge stile and lock stile was capped with 5/16" by 1-5/16" wood. The top and bottom rails, and lock stile contained 20 gauge by 3-1/2" steel reinforcement. The hinge stile contained 20 gauge 1-7/8" steel reinforcement.
