THERMA-TRU CORPORATION ACOUSTICAL PERFORMANCE TEST REPORT

ASTM E90 SOUND TRANSMISSION LOSS TESTING ON A FIBER-CLASSIC/SMOOTH-STAR DOOR, 3068 DOOR WITH FIBERGLASS SKIN

I4812.01-113-11-R1

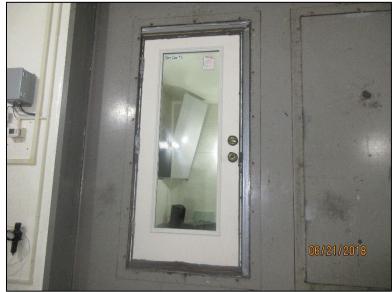
Photo No. 1 Receive Room View of Installed Specimen

The specimen plug was removed from the filler wall assembly. The specimen was placed on an isolation pad in the test opening. Duct seal was used to seal the perimeter of the specimen to the test opening on both sides. The interior side of the specimen, when installed, was approximately 1/4" from being flush with the receive room side of the filler wall. A stethoscope was used to check for any abnormal air leaks around the test specimen prior to testing. Operable portions of the test specimen, if any, were cycled at least five times prior to testing.

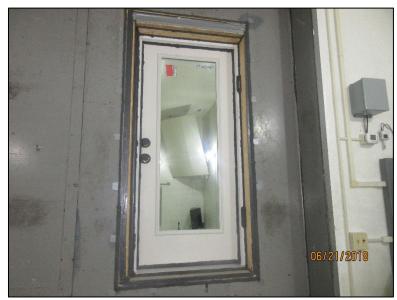
Photo No. 2 Source Room View of Installed Specimen
